REPORT OF FINDINGS

Claim No: 36-13Z0-28D

**INSURED: DONALD LEJEUNE
327 NORTHWEST 12TH AVENUE
NORMAN, OKLAHOMA 73072**

ProNet File No: 47355
SFF&CC/Lejeune 00274

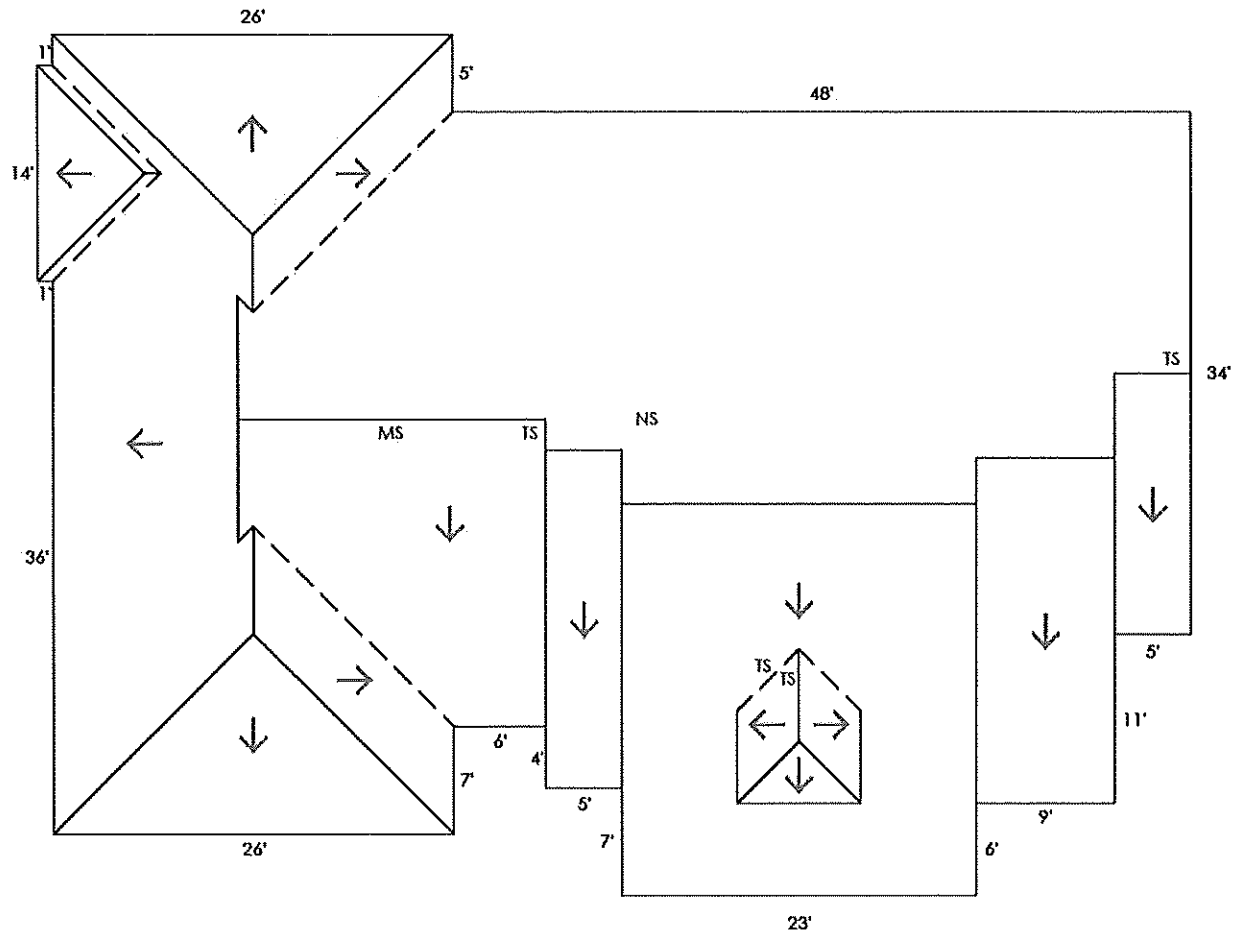
A. ROOF LAYOUT

1. LOCATIONS/SIZES/DIMENSIONS ARE APPROXIMATE.
2. ROOF IS COVERED WITH APPROXIMATELY 4 700 SQUARE FEET OF ASPHALT SHINGLES.
3. TYPICAL ROOF SLOPE IS 10/12 UNLESS NOTED OTHERWISE.
4. MULTIPLE LOCATIONS OF UNBONDED SHINGLE CORNERS IN A DIAGONAL STAIRSTEP PATTERN.

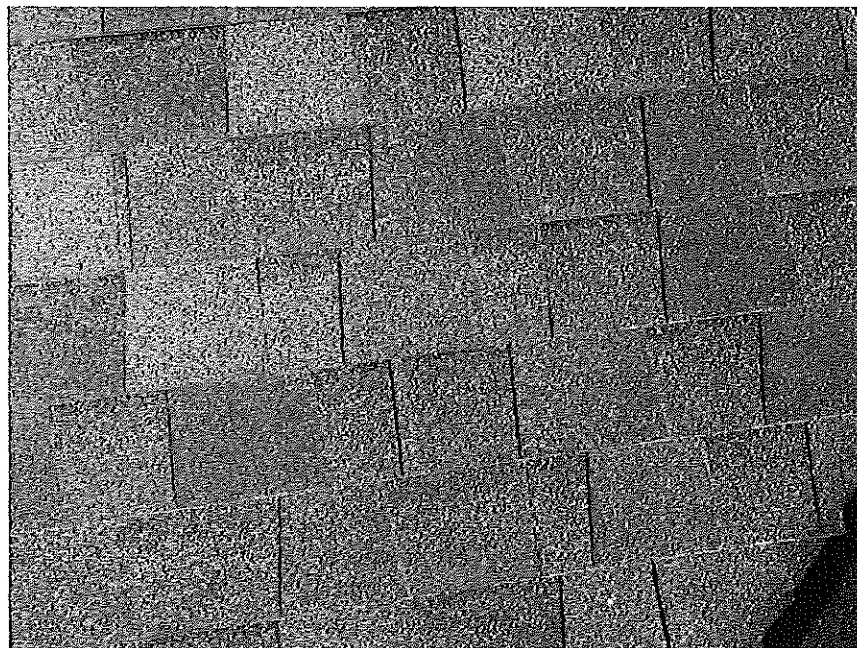
9. View of typical shingles. Note the lack of spatter marks.

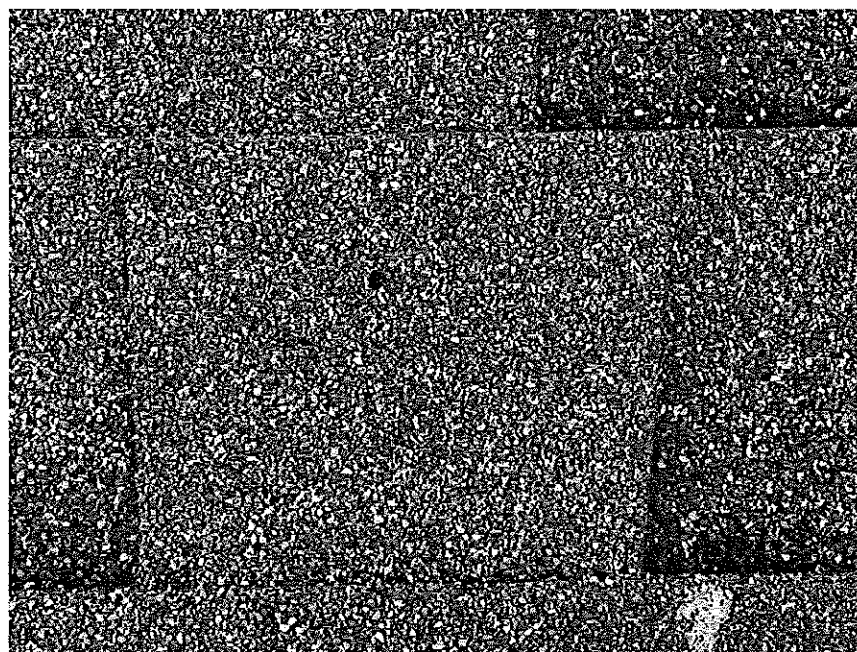
Shingle blisters occur from a combination of poor-quality asphalt combined with heat. They appear as small bubbles in the shingle surfaces when trapped moisture within the asphalt base sheet expands as it is heated by the sun. As the asphalt covering is heated, the expanding moisture ruptures, and the overlying granules are displaced leaving small areas of missing granules with steep sides. These areas are distinguishable from hail impacts because they are typically smaller in size than the diameter of hailstones required to displace granules from asphalt shingles and have square vertical edges at the perimeter of the area of missing granules.

10. View of a typical blister on a shingle.

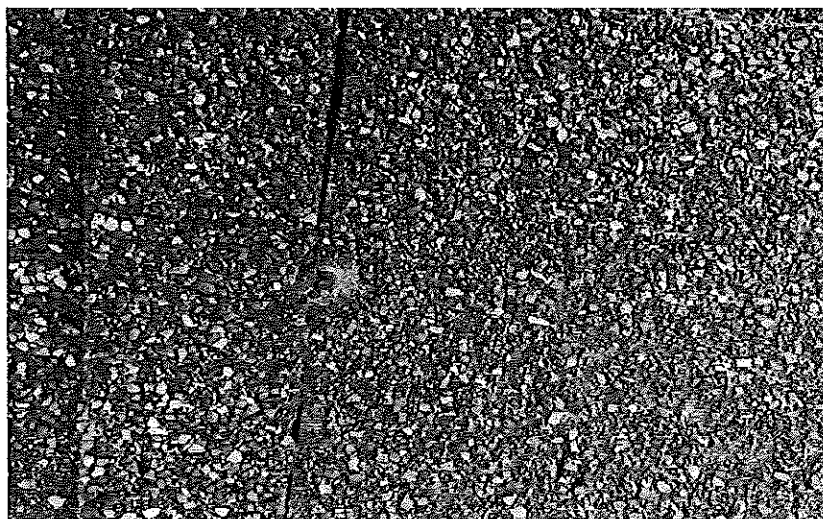
The scattered exposed shingle fibers are consistent with aging and wear and tear over the years from exposure to the environment. Mechanical damage (marring from foot traffic, shipping, maintenance, storage, fabrication, and/or knife slices from installation) and manufacturing deficiencies (where the granules did not adhere to the base coat and/or the base coat was too thin to bond to the granules) also contributed to the exposed shingle fibers.

11. View of typical exposed fibers on a shingle.

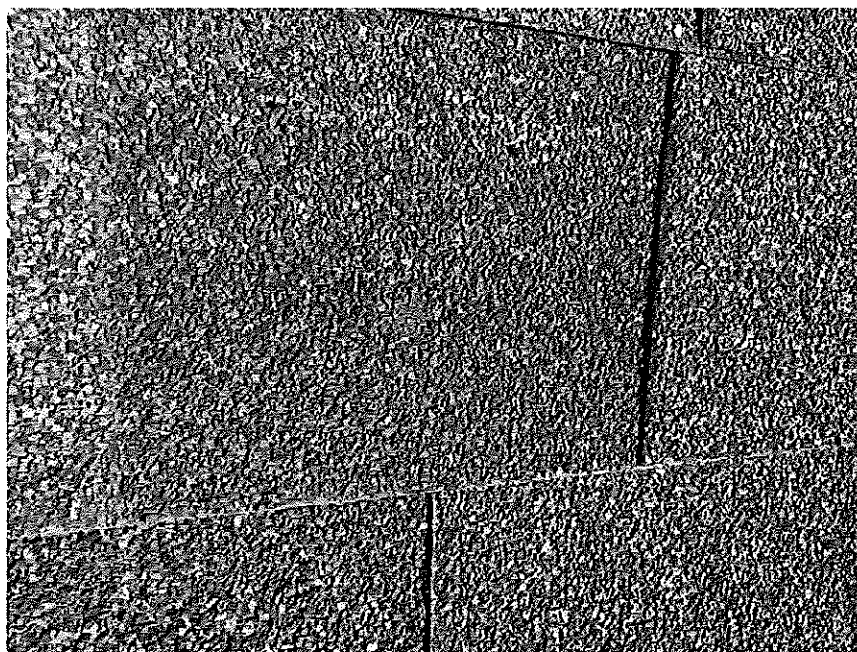
Granular loss is normal and should be expected from the moment shingles are manufactured, shipped, installed, and during the weathering process. Granules are part of the wearing surface of the shingle and therefore small quantities of granules are expected to be removed from the shingles during weather events over the useful life of the shingles; however, that condition does not adversely shorten the expected life of the shingles or adversely affect the water shedding ability of the shingles.

12. View of typical granule loss on a shingle.

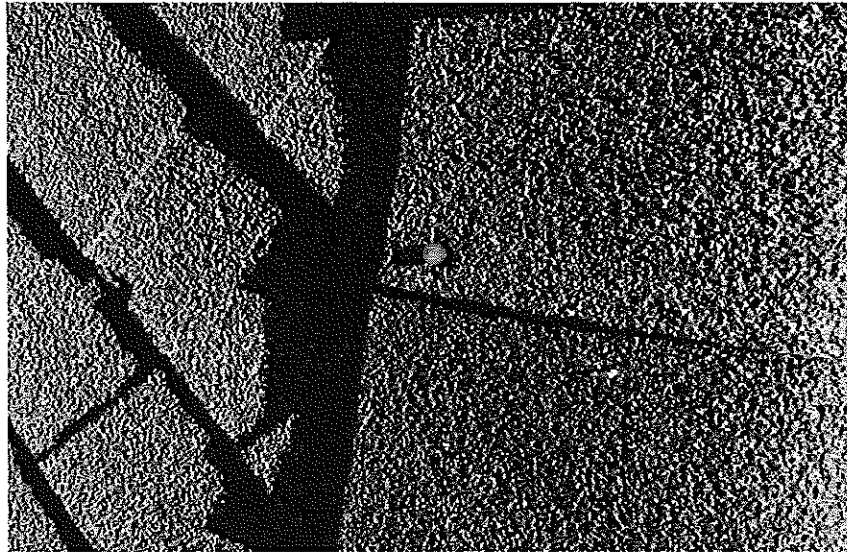
13. View of a typical nail pop.

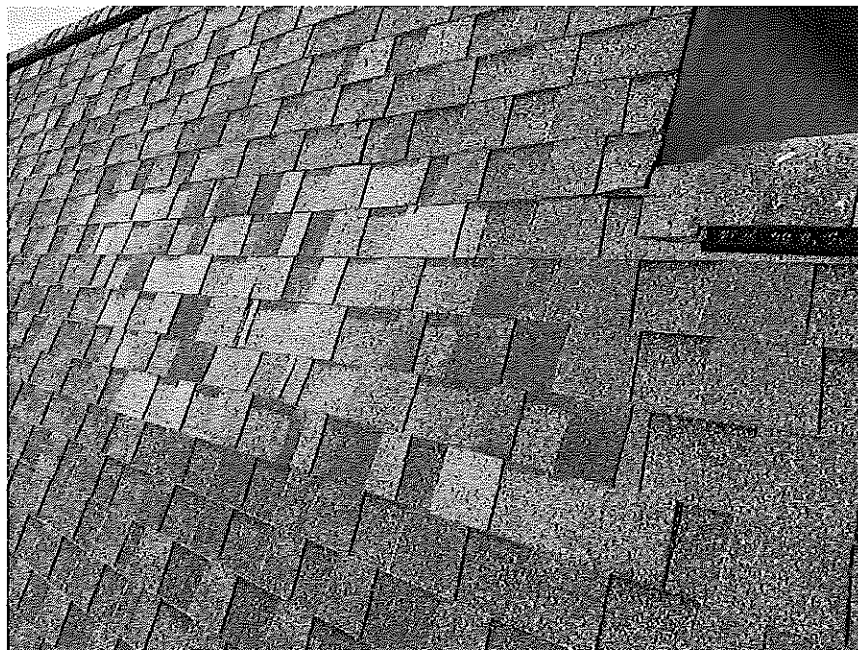
14. View of an area of newer shingles where roof vents were reportedly located.

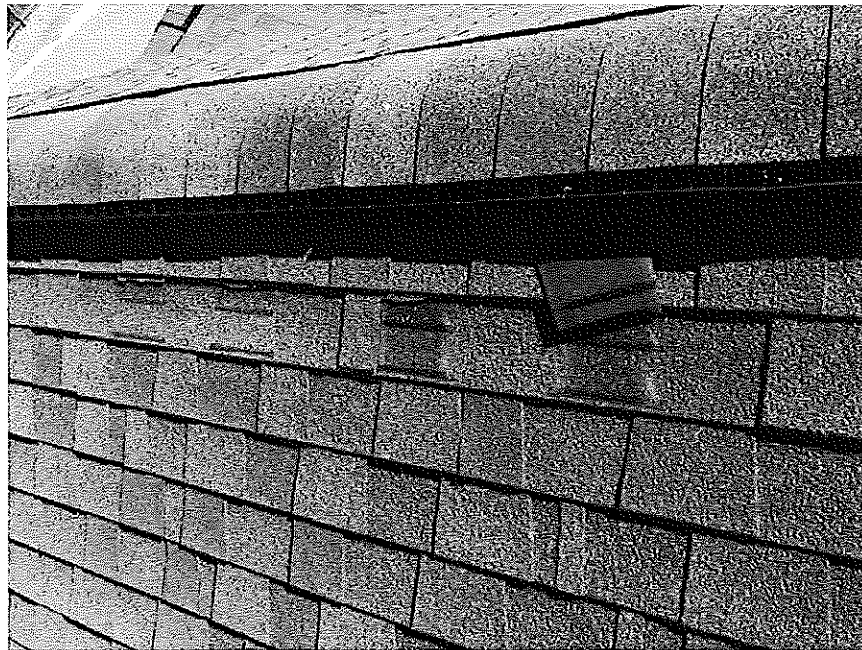
15. View of an isolated area of missing shingles near the ridge on the west roof slope.

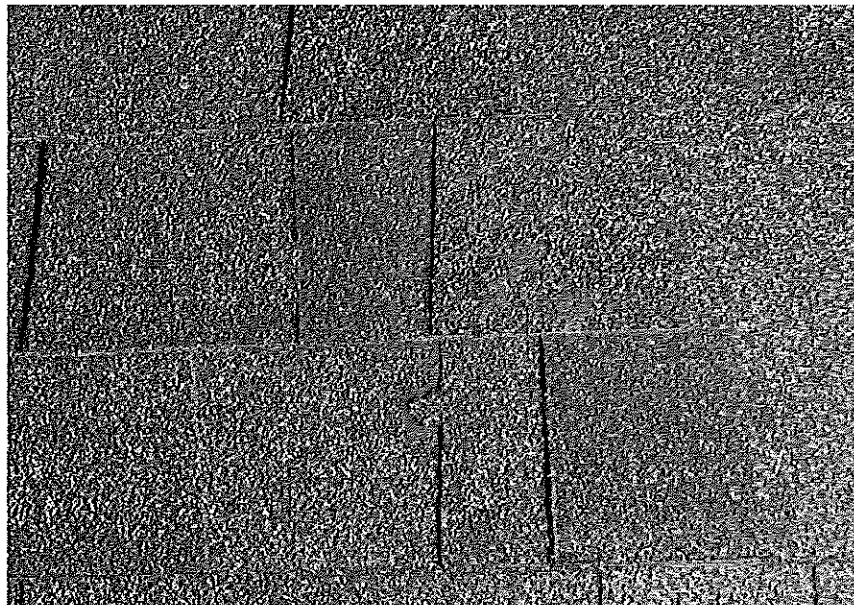
16. View of an isolated torn shingle.

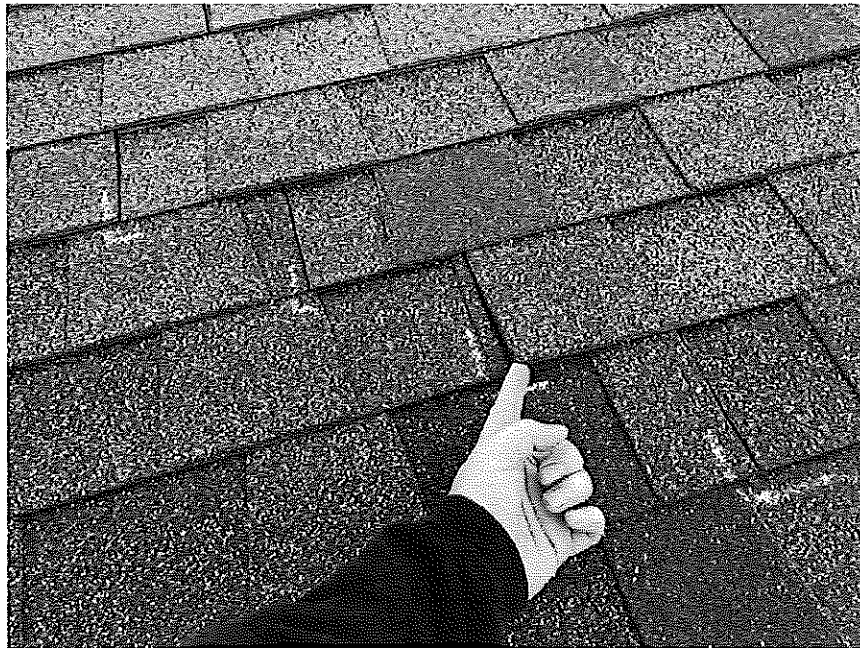
Partially and fully unbonded shingle ends commonly occur as asphalt shingles age. Once roof shingles are installed, the moisture and oils retained in the asphalt material begin to slowly dissipate from sun and heat exposure. As the weathering process continues, the shingles shrink causing tension forces within the shingles, particularly along the horizontal length of the shingle because it has the largest dimension and, therefore, experiences the greatest dimensional change. The wood substrate below the shingles also expands

The unbonded shingles were randomly located over all roof slopes. Typically, wind damage from a storm event will cause damage to one section or side of a roof slope, but not necessarily over all the roof slopes. Furthermore, the unbonded shingles exhibited no creases in the surface of the shingles, indicating they were not unbonded as a result of elevated wind force, which would have flipped the shingle and creased the topside. Our inspection of the roof slopes revealed no damage or pattern of damage that would indicate the roof shingles were damaged by excessive wind forces acting on the structure.

17. View of typical unbonded shingle corners in a diagonal, stair-stepped pattern.

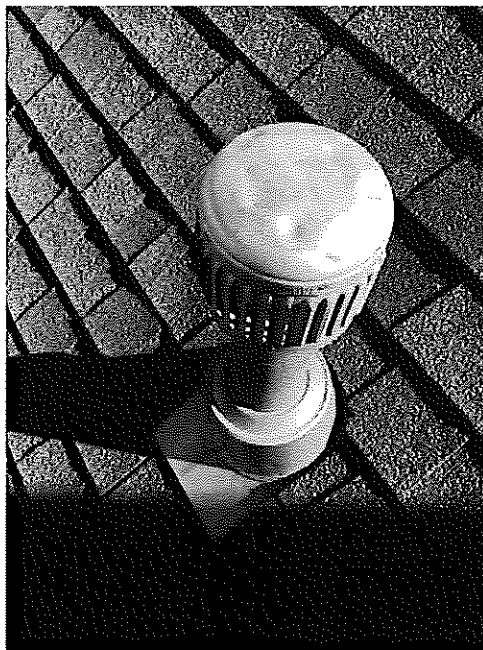
property indicate that hailstones have impacted the roof surfaces previously. However, because they are formed of unsupported light-gauge metal, it is common for metal roof vents to sustain cosmetic dents from hailstones of smaller size than that necessary to cause damage to the asphalt roof shingles.

The dents in the metal vent caps and flashing are cosmetic in nature as there was no evidence of penetrations through the metal (which would allow water to penetrate) nor damage that would affect the functionality or structural integrity of the components.

18. View of a typical dented metal vent cap.

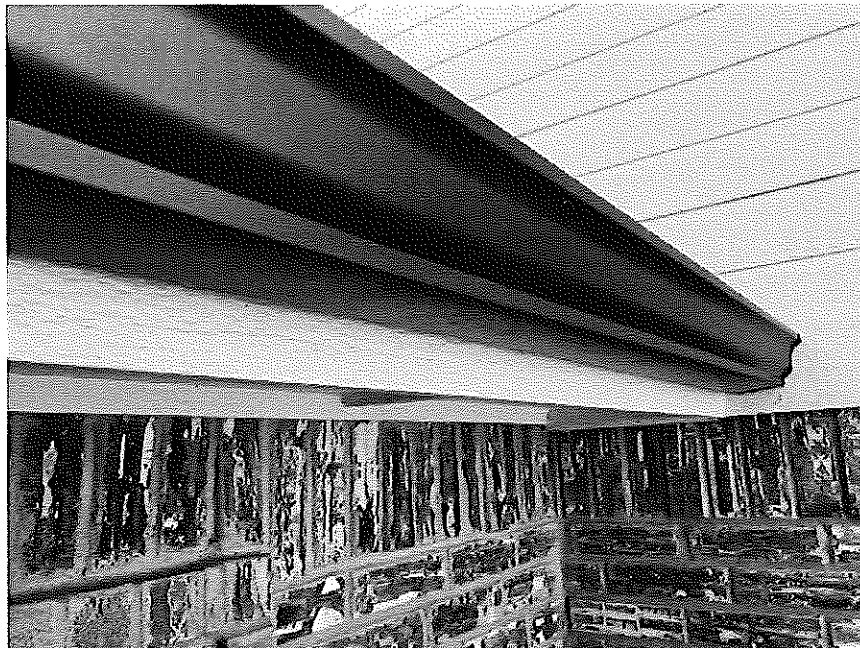
19. View of a typical metal gutter. Note the lack of dents.

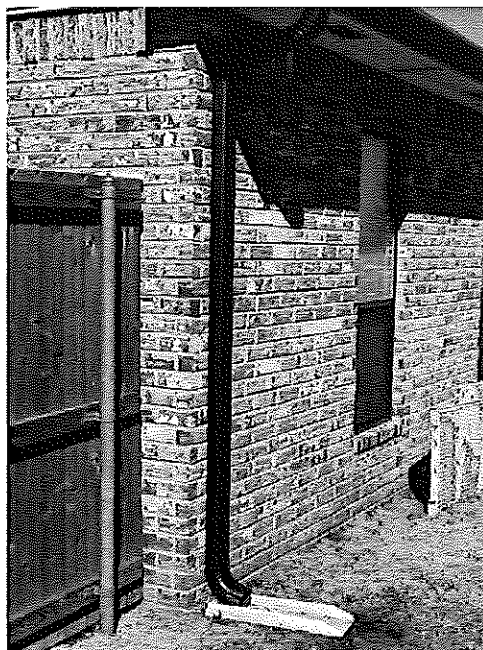
20. View of a typical metal downspout. Note the lack of dents.

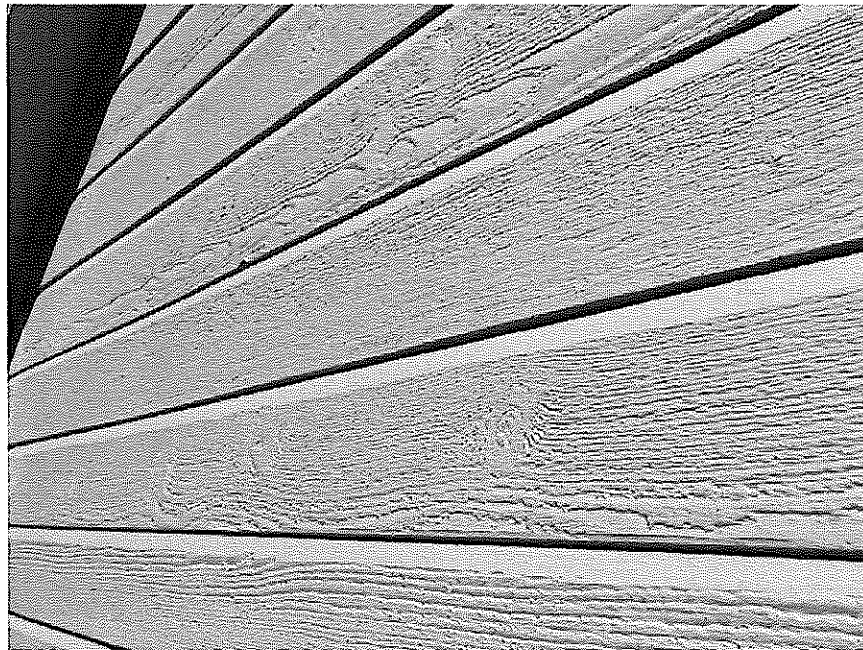
21. View of typical wood siding. Note the lack of evidence of hailstone impacts.

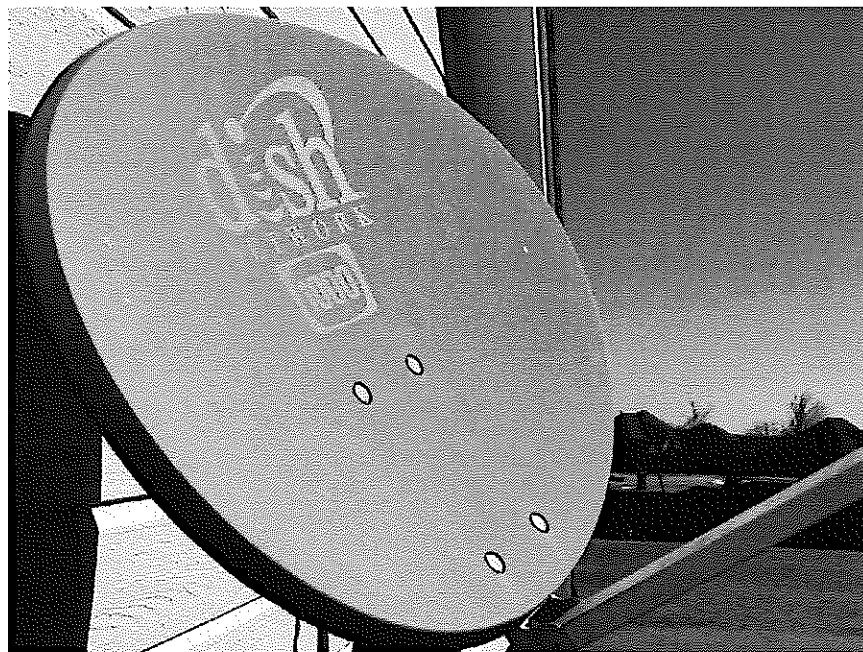
22. View of the satellite dish. Note the lack of spatter marks or damage.

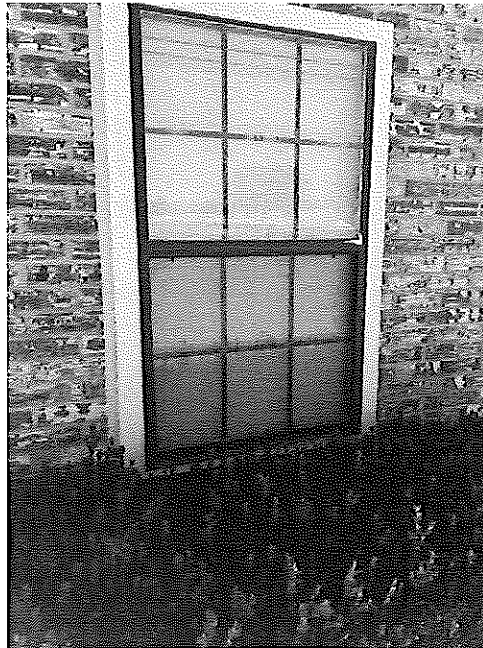
23. View of a typical unbroken window.

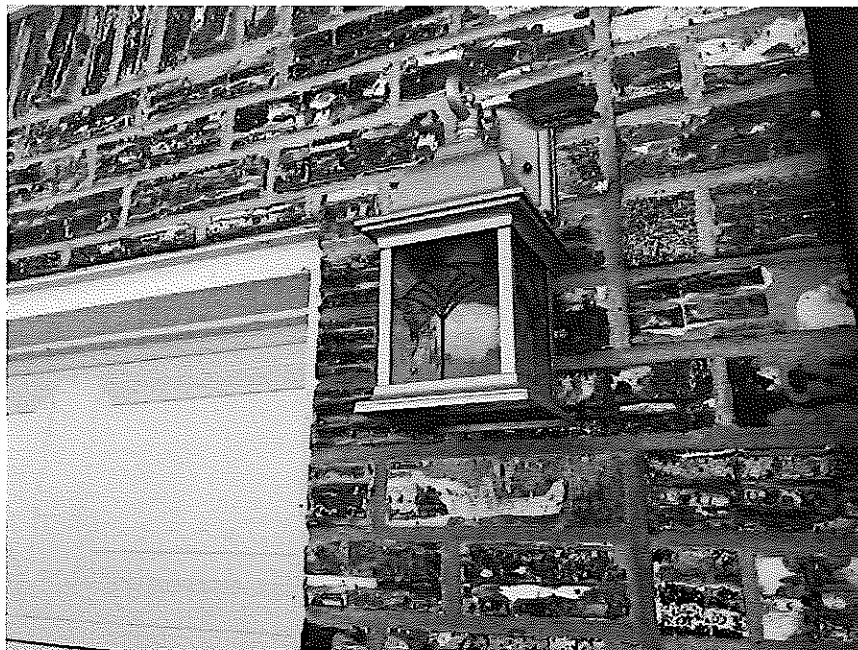
24. View of a typical undamaged light fixture.

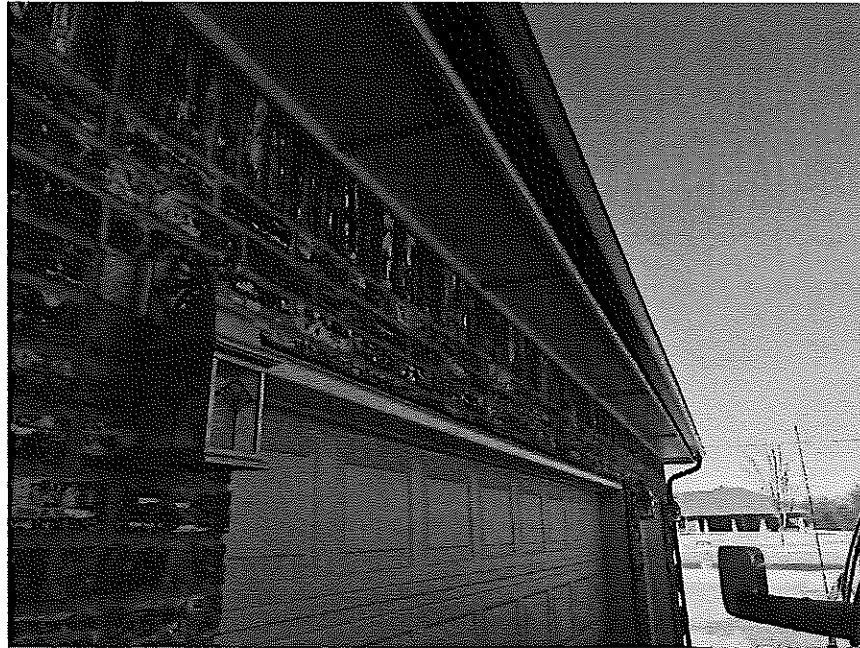
25. View of a typical soffit. Note the lack of evidence of damage.
